## AVIATION INVESTIGATION REPORT

A04C0174

### LANDING GEAR COLLAPSE AND RUNWAY EXCURSION

FAIRCHILD SA-227-AC METRO III C-FIPW

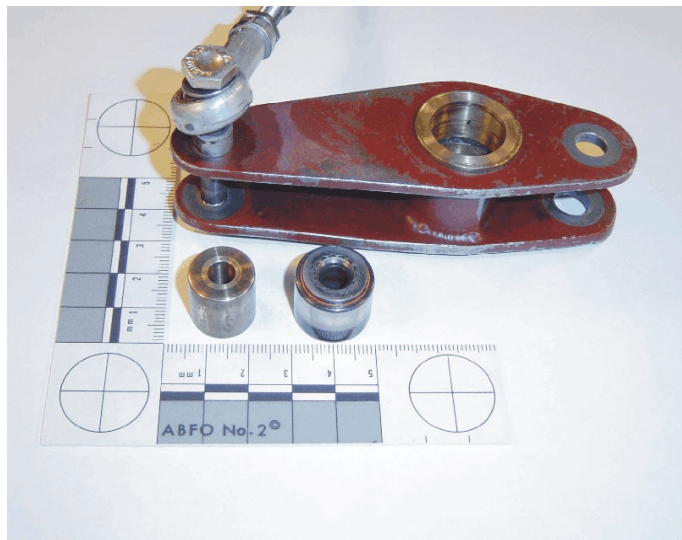
The outboard bellcrank roller could not be measured because the roller was found to be undersized (0.625-inch diameter instead of the designed 0.750-inch diameter). The smaller diameter roller reduced the required rigging allowances for the bellcrank-to-cam assembly in the down-and-locked position. Marks or gouges were found on the roller where the lip of the positioning cam had been making contact.

A review of the aircraft technical records showed that the left gear outboard bellcrank roller had been replaced with a part number 5453032-1 roller on 09 August 2004, approximately 209 flight hours prior to the accident. The manufacturer's parts manual shows part number 5453032-1 to be that of a landing gear uplock roller for this type of aircraft's vice bellcrank roller; it is made of a solid bushing material (see Photo 1). The proper bellcrank roller is listed as a part number YCRS-12 bearing, comprised of an outer race running around rollers over an inner race. The YCRS-12 bearing roller is larger in diameter than the one installed.

**Photo 1.** Bellcrank assembly with a part number 5453032-1 roller on the left and a YCRS-12 bearing on the right

The roller installed on the outboard landing gear bellcrank was of a smaller diameter than the required part and was designed to be used as an uplock roller vice bellcrank roller. The smaller diameter of the roller reduced the required clearance in relation to the roller's location on the heel of the positioning cam. Repetitive landing loads transmitted through the drag brace were initially absorbed by the roller hitting the lip of the cam, until the lip of the cam was worn away. The wear eventually allowed the roller to move beyond the cam cutout position. Consequently, the drag brace was primarily held in the down-and-locked position by the inboard bellcrank roller and the positioning cam, both of which were out of adjustment and held in position by spring tension only.

All maintenance staff of the AMO responsible for Northern Dene Airways Ltd.'s aircraft met to review the company's maintenance procedures outlined in its *Maintenance Policy Manual*. The following policy was reinforced: "No one is to install any parts on any aircraft without first referring to the appropriate parts and service manuals to ensure correct part number and also that the integrity of the affected aircraft system is still in place."

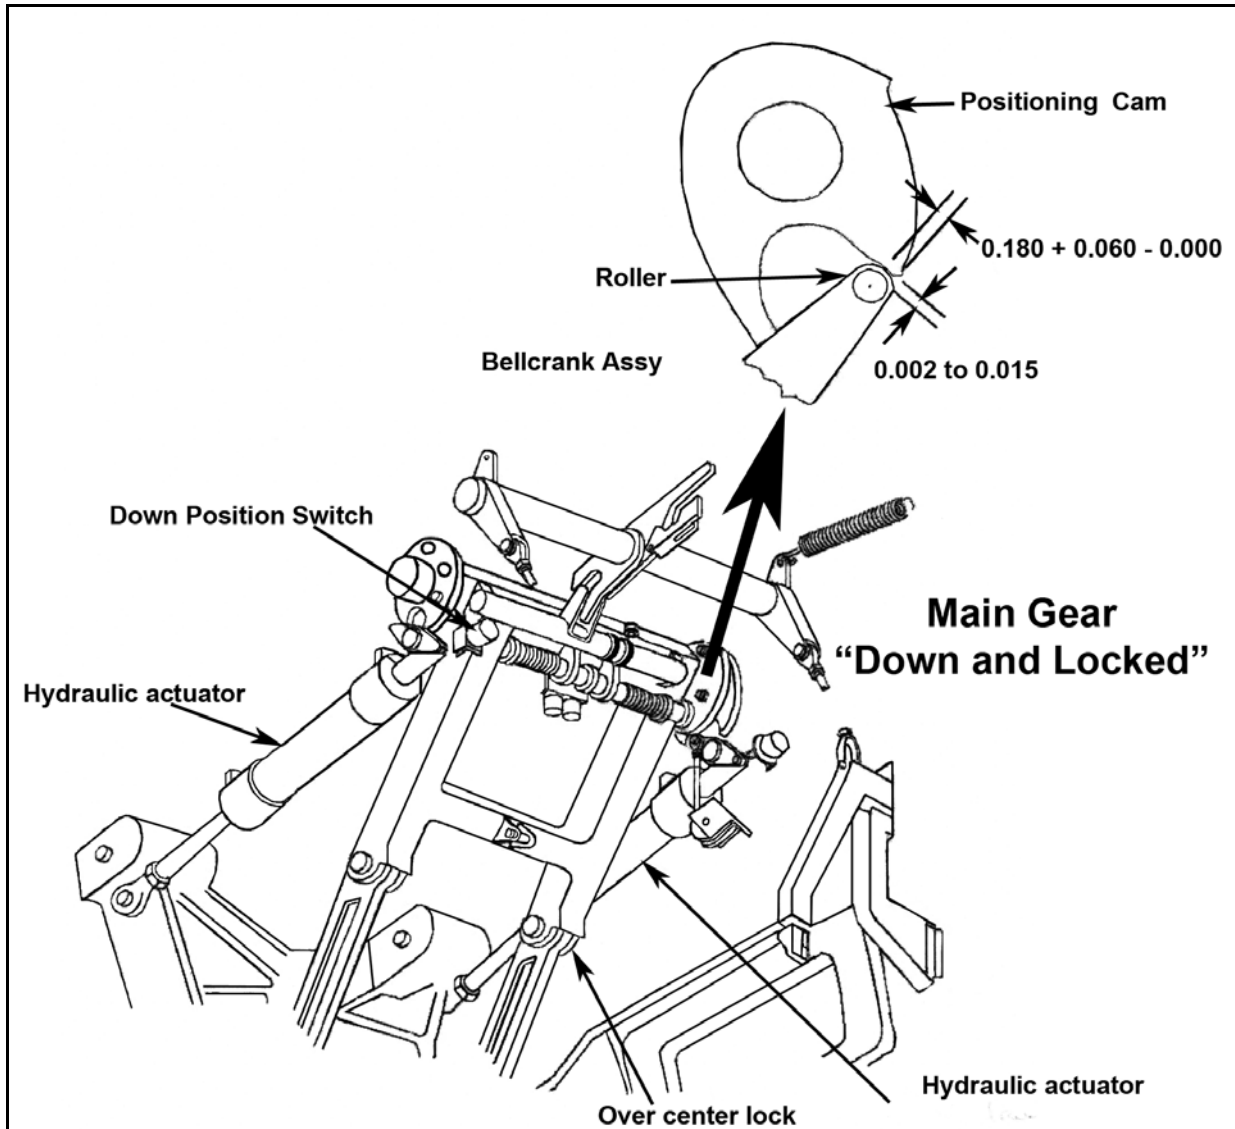
# Appendix A – Main Landing Gear Retract Mechanism

The landing gear is designed with a three-piece drag brace attached to the gear struts and the aircraft wheel wells. Each drag brace hinges at both ends and in the centre to allow it to fold up into the wheel well during retraction. To ensure that the gear will remain down and locked during ground operations, the drag brace centre hinge travels slightly upward, to a locking overcentre travel limit stop, opposite to its normal folding movement. Because the drag brace hinges at three points, devices are needed to hold it against its overcentre stops. Two of these devices are positioning cams that bolt to the inboard and outboard ends of each upper drag brace. Each cam has a concave cutout to receive the roller of a bellcrank and roller assembly, which is mounted to the aircraft wheel well. When the landing gear is fully extended, the drag brace is forced into its overcentre position by the bellcrank roller resting against the heel of the positioning cam. With the roller in this position, the gear is said to be in the “down and locked” position.

An inboard and outboard hydraulic actuator is mounted on each of the main landing gear assemblies to assist extension and retraction. To prevent the landing gear from collapsing, the position of the bellcrank roller relative to the cam cutout is critical and is determined by adjusting the length of the landing gear actuator rods.

The bellcrank assembly roller is held in its locked position by hydraulic pressure in the fully extended actuating cylinder and by spring tension. During normal extension of the main gear, only the outboard cylinders are pressurized with the inboard bellcrank being held by spring tension only. Two down-indication micro switches (one at each actuator bellcrank) provide a gear-down indication in the cockpit when both micro switches are activated.
